Subject: Front Electric Sustainer Wiring – Inspection / Modification**Ref. Publications:**

Schempp-Hirth Technical Note (TN) 627-8 original issue dated 01 January 2024.

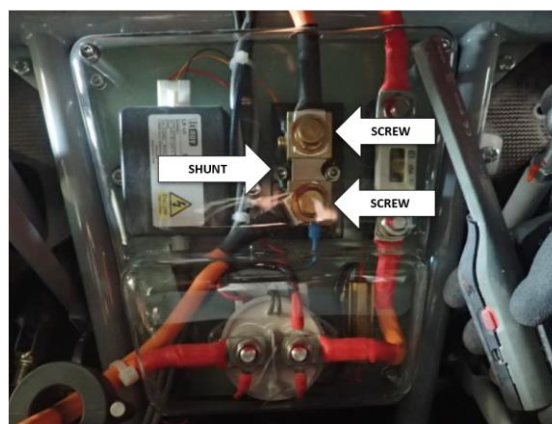
Figure 1 - Affected Screws Location

Occurrences were reported of brass screws fixing cable to a shunt between the negative pole of the Front Electric Sustainer (FES) battery and the controller (see Figure 1) that have torn off, possibly due to excessive tightening torque used in maintenance.

This condition, if not detected and corrected, could lead to FES loss in flight.

- Inspect if FES wiring is assembled with the affected brass screw(s) (see Figure 1).
- If, during the above inspection, any brass screw(s) is found installed, replace that screw with a steel one, in accordance with applicable Schempp-Hirth TN.
